Report of the Commission of Inquiry into
the Collision of Vessels near Lamma Island on
1 October 2012

The Honourable Mr Justice Michael Lunn, JA
Mr Benjamin Tang, GBS, JP

April 2013

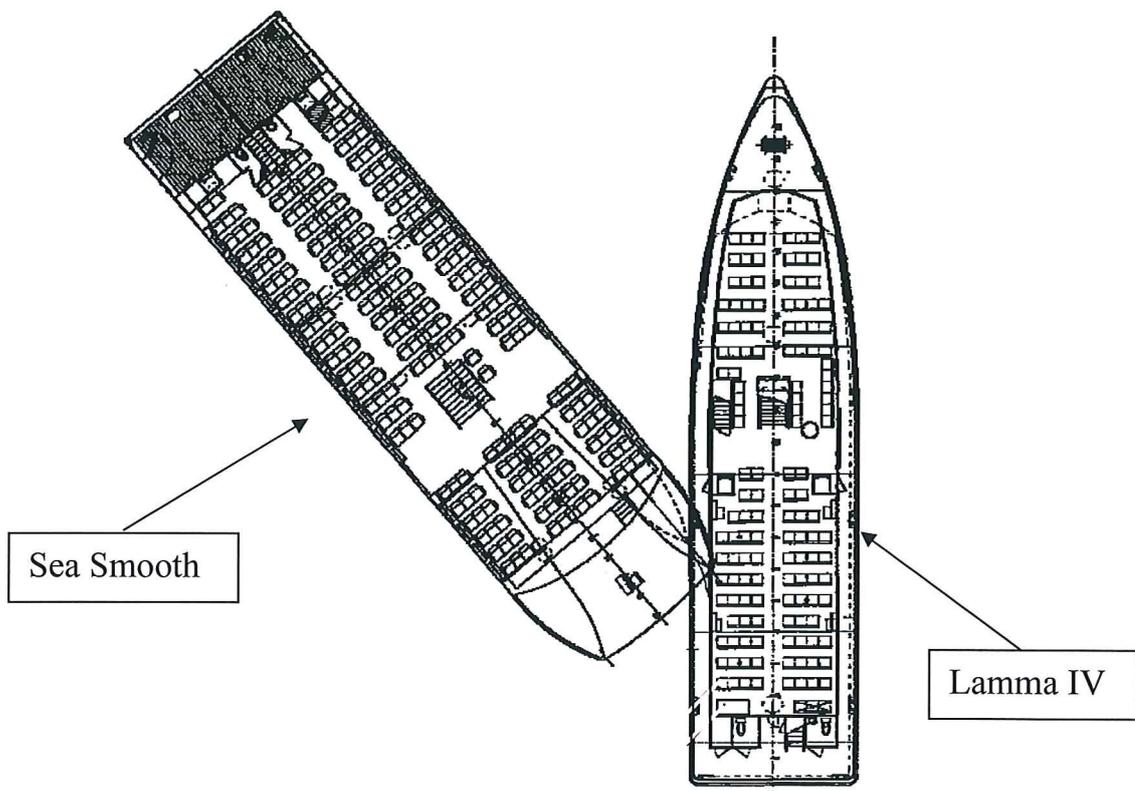
Sketch in plan view showing the relative positions of the Sea Smooth and the Lamma IV during collision

Lamma IV at 11.5 kn, Sea Smooth at 22.5 kn, relative heading 40°

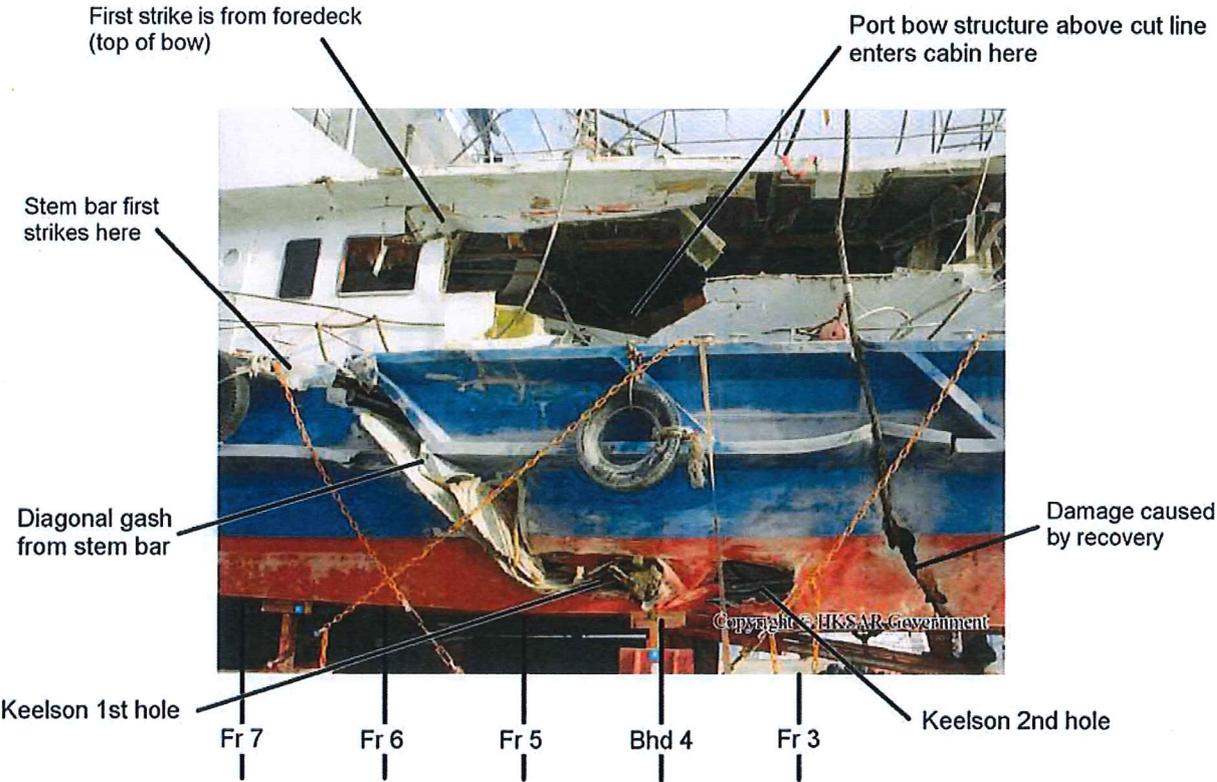
Principal damage to the Lamma IV watertight integrity

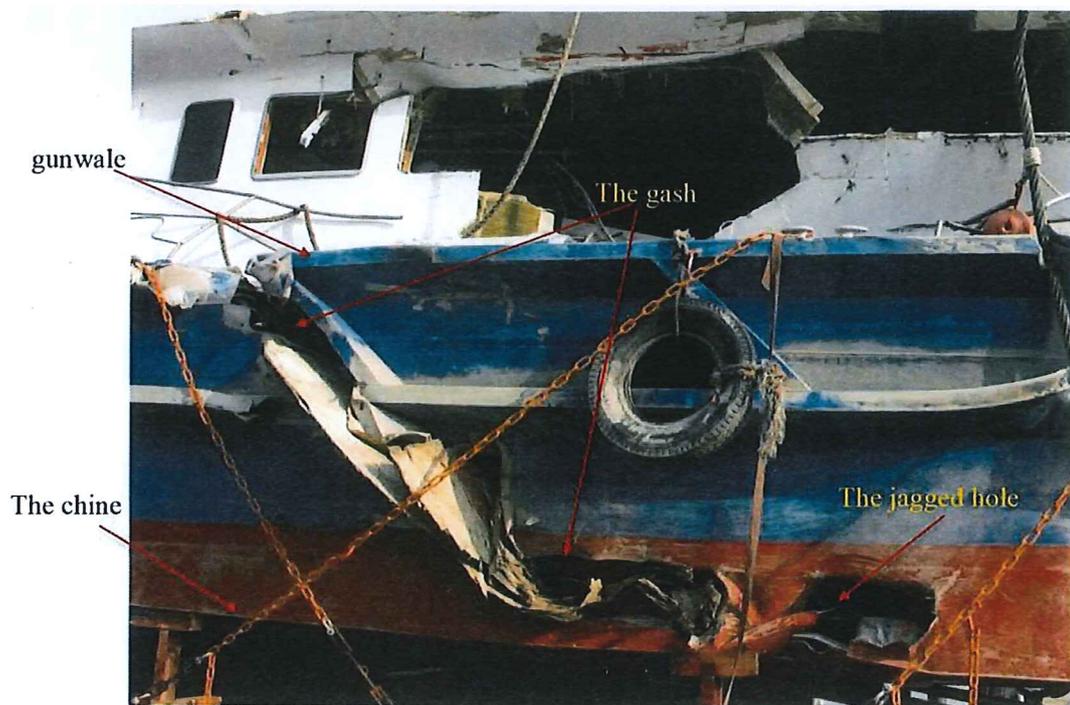
**The gash and the jagged hole on the port side of the hull
of the Lamma IV**

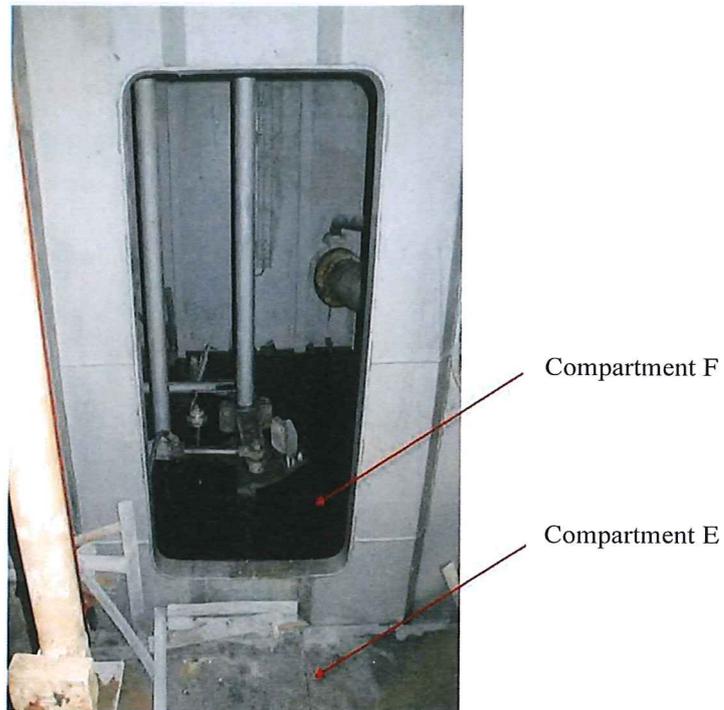
The non-watertight bulkhead between Compartments E and F with an opening

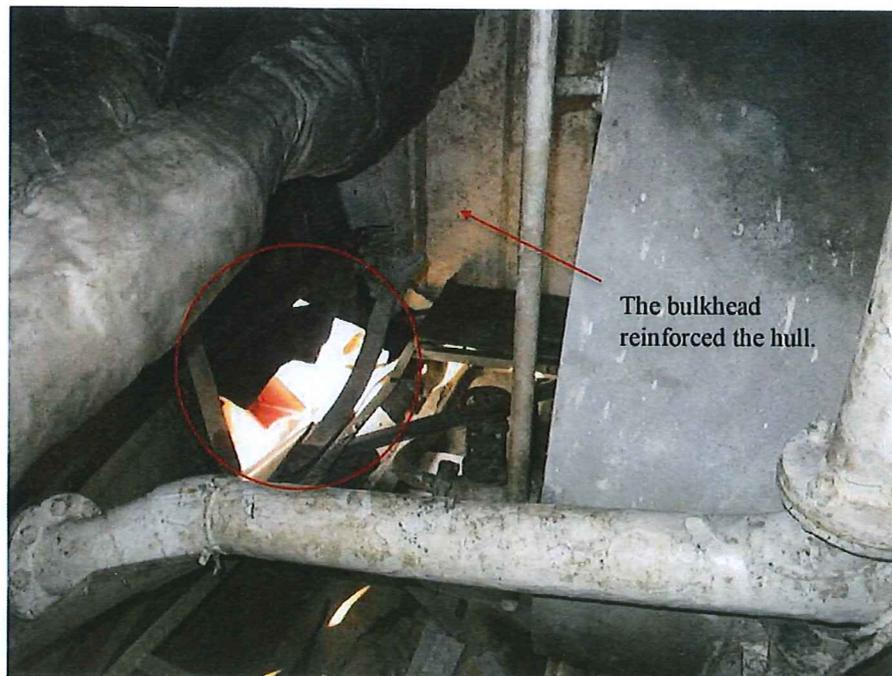
The jagged hole (red circled) in the tank room (Compartment E) of the Lamma IV

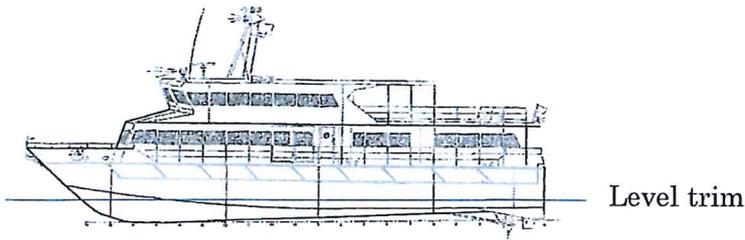
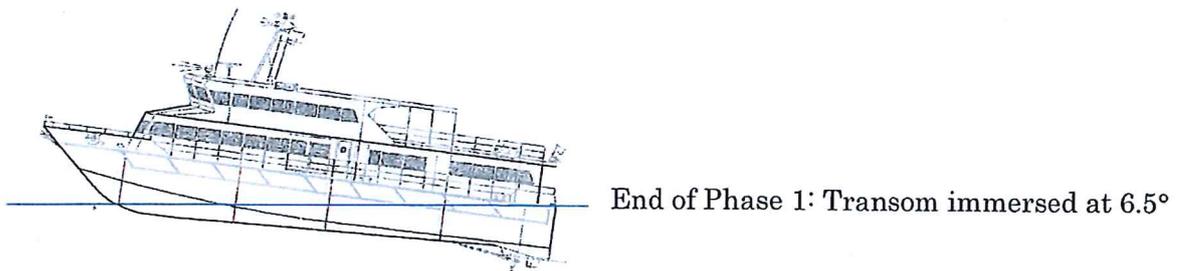
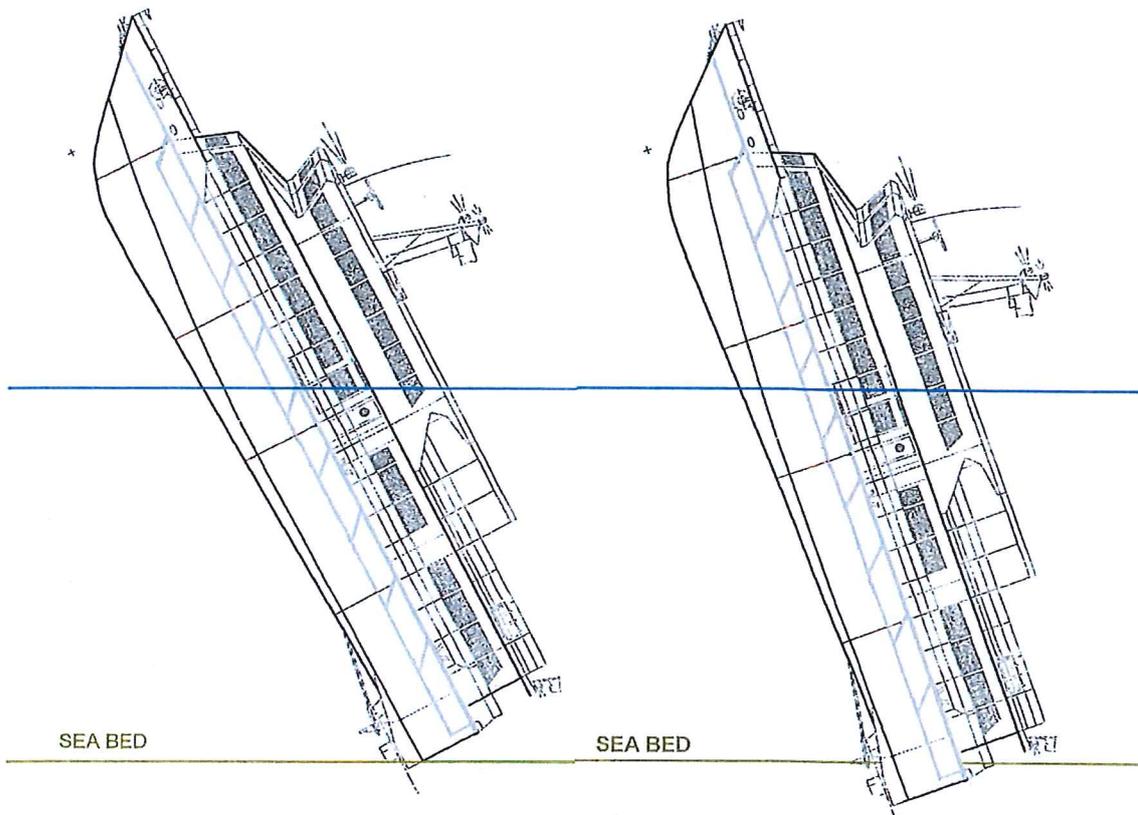
Angles assumed by the Lamma IV after sinking

End of Phase 2: Transom in contact with sea bed.

End of Phase 2a: Vessel settles into the mud on the sea bed.

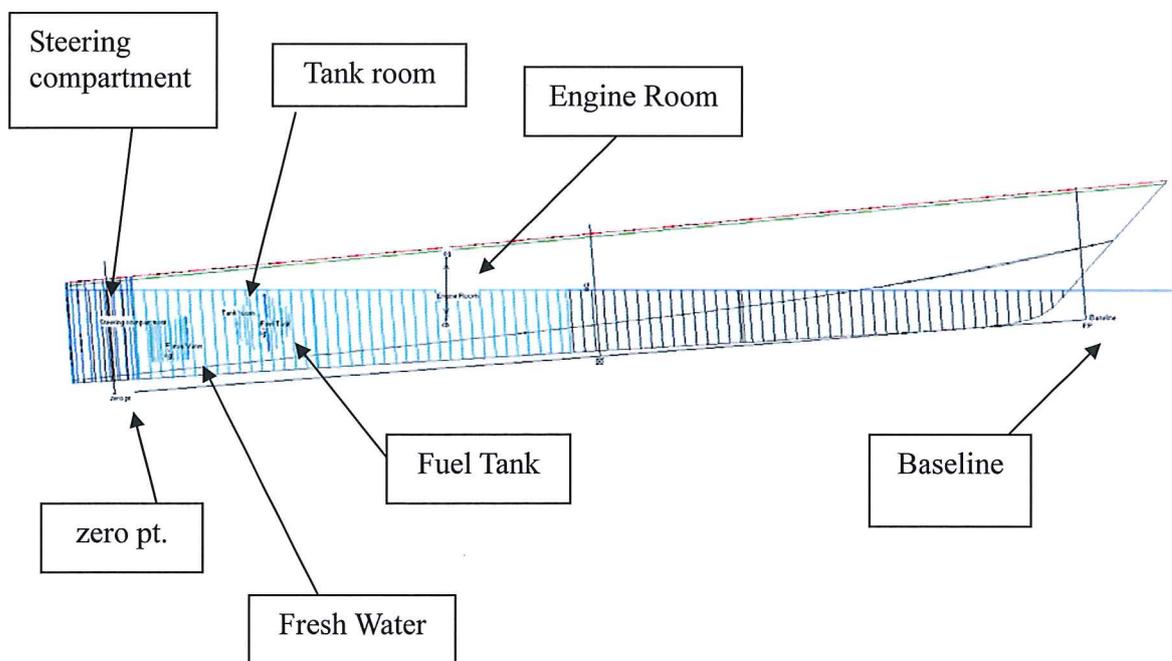
Two-compartment Damage – Engine room and Tank room

Note that the stern is almost submerged, but the vessel remains afloat

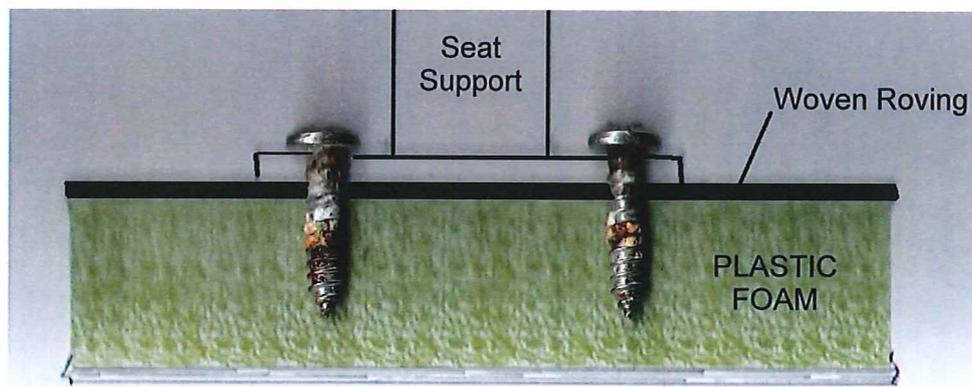
Sketch of the seat foundation arrangement on the Upper deck of the Lamma IV

This sketch is drawn to scale from the construction drawings, using two of the actual screws remaining on the upper deck.

Only the black part marked as “Woven Roving” makes a structural connection with the screws, the plastic foam having no strength to resist “pull-out”.

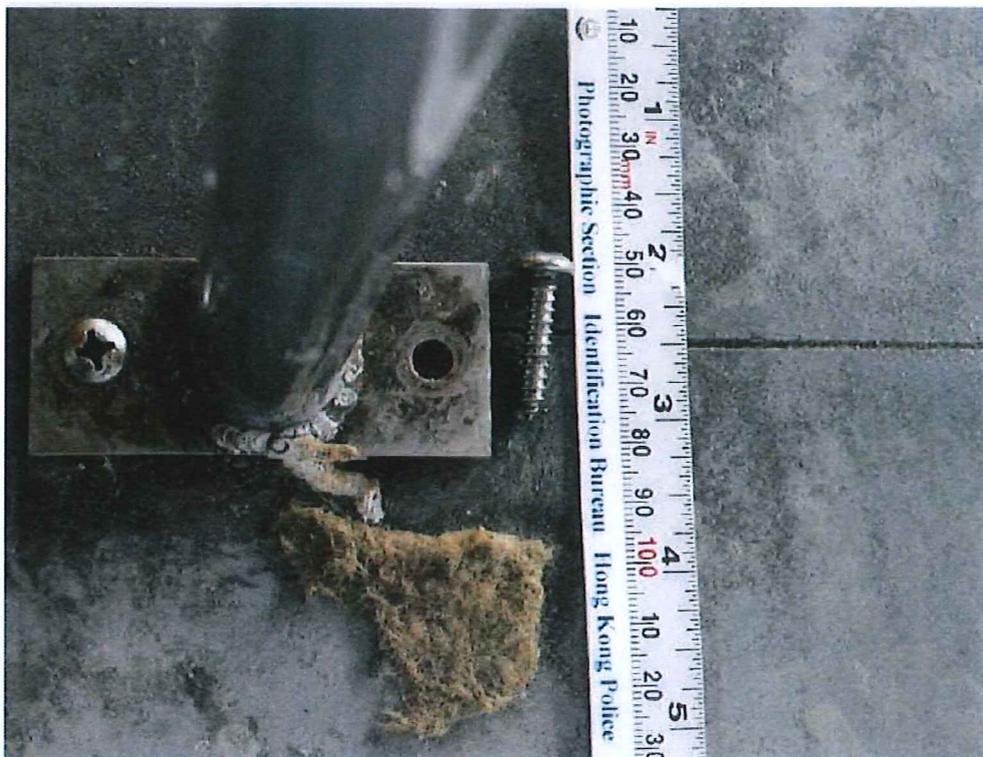
The rectangular mounting plate at the base of the leg of seat in the Upper deck cabin of the Lamma IV and the screw for affixing the seat

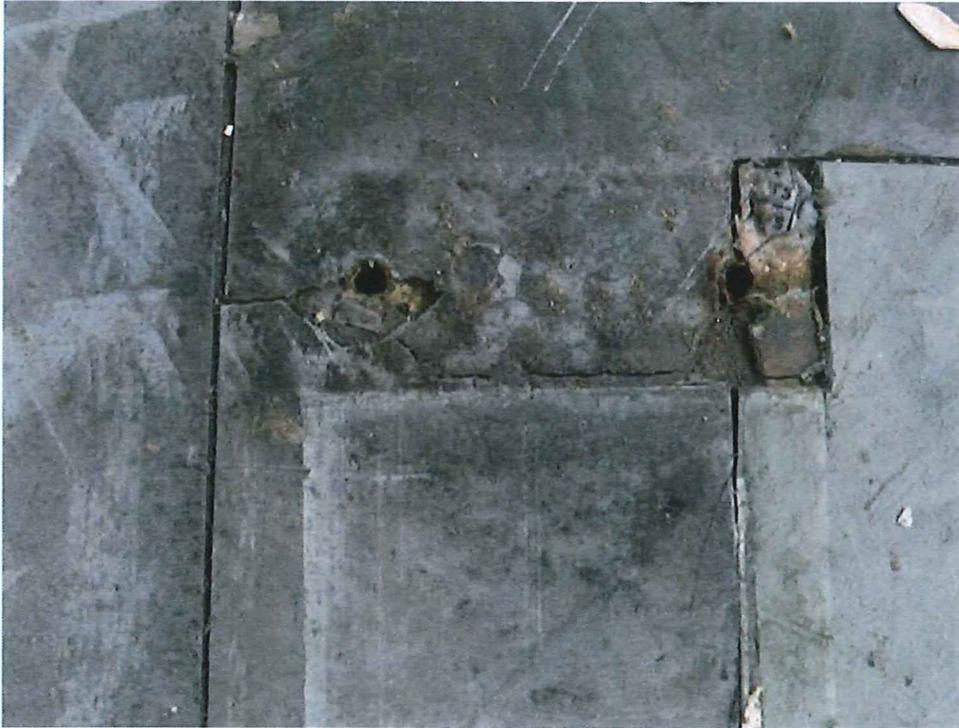
The rectangular imprint on the deck of the Upper deck cabin of the Lamma IV

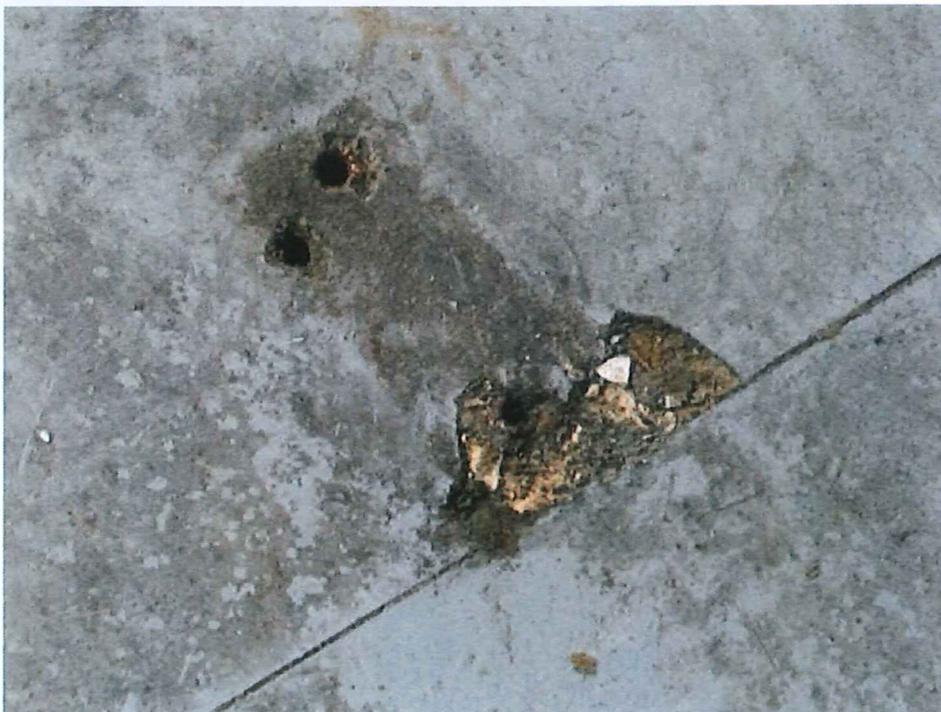
The mounting place had more than a pair of mounting holes

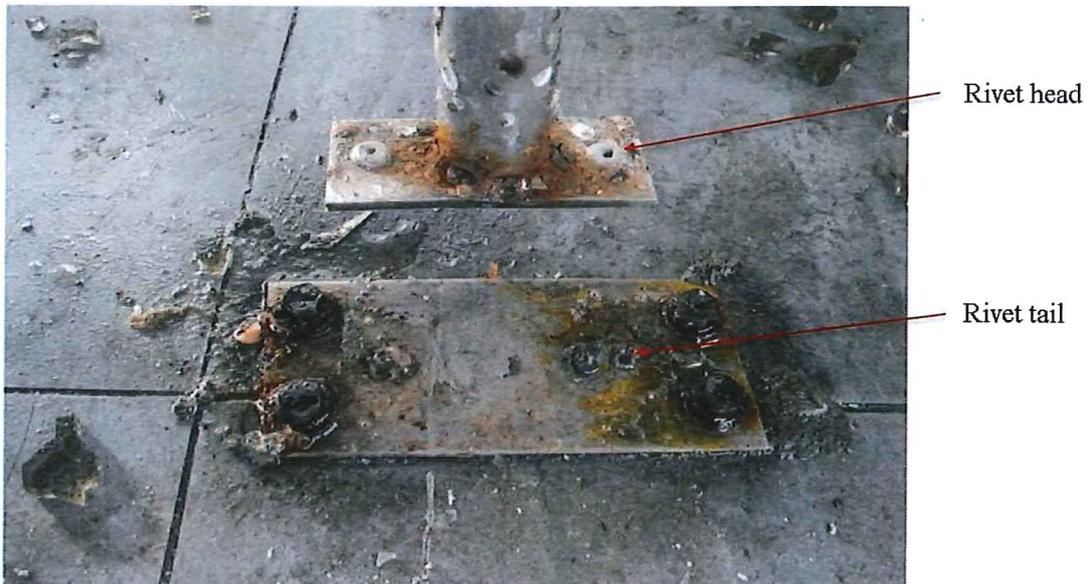
The mounting plate of the leg attached with heads of two rivets and the rectangular metal plate attached with rivet tails
